## 2<sup>nd</sup> Gear starts, 3<sup>rd</sup> Clutch failure

### 3-4 Shift Valve Kit

**77754-42K**

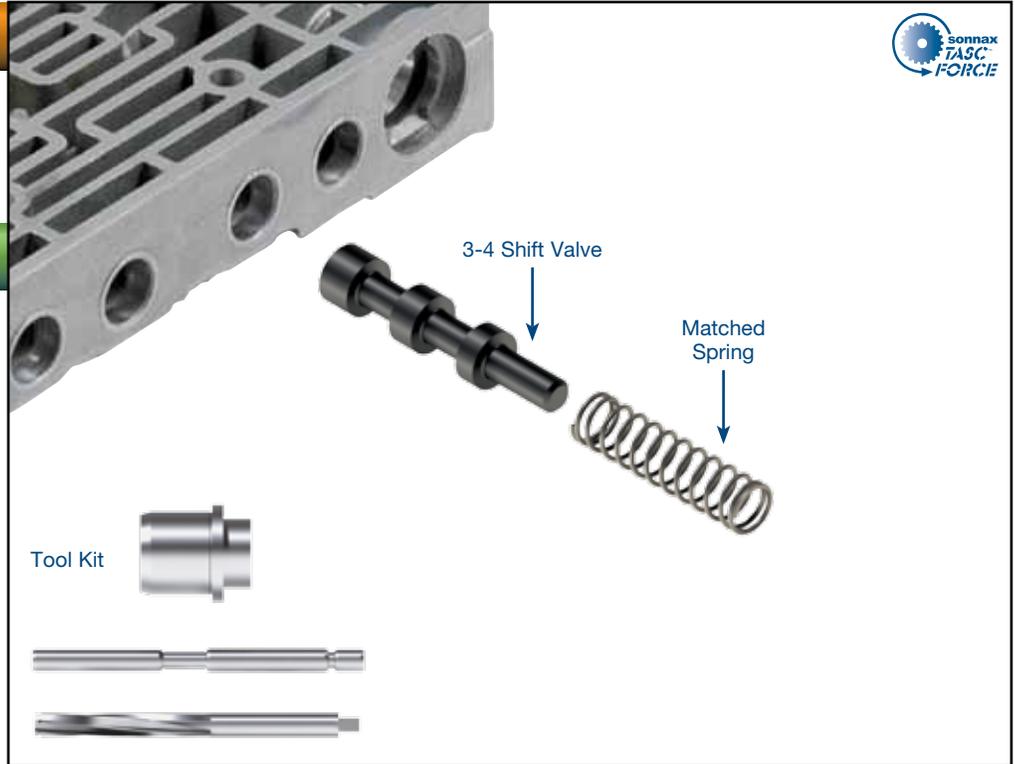
Wear at the shift valve spools and bore lands allows loss of critical hydraulic pressure. Typically wear is most severe at the signal "A" spool/land.

Wear at the shift valve spools and bore lands causes loss of critical hydraulic pressure which, depending on the wear location and severity, can result in shift timing/feel complaints, 2<sup>nd</sup> gear starts, 3<sup>rd</sup> clutch failure, 3-4 shift complaints and loss of AFL pressure.

Ream the valve bore to restore bore geometry and surface finish. Install the Sonnax oversize valve and matched spring.

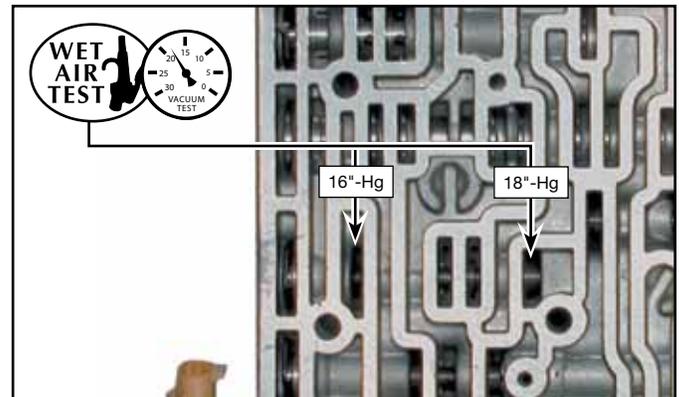
A wet air test or a vacuum test at indicated valve body locations result in leakage or below recommended in-Hg levels.
