## COMPLAINT

2<sup>nd</sup> or 3<sup>rd</sup> gear starts, TCC slip or cycling RPM

### Solenoid Regulator Valve

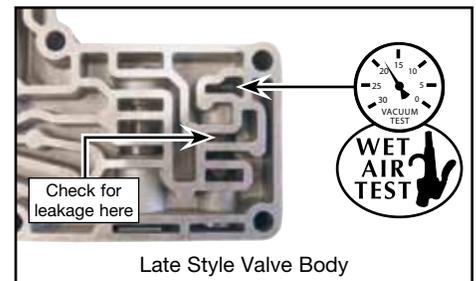
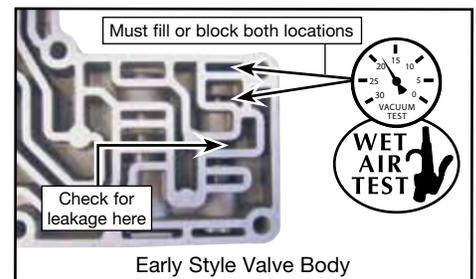
#### 36947-14

**NOTE:** Fits late-style, '96-later, two-spool valve version.

**NOTE:** Fits early-style, '95-earlier, three-spool valve version.
