**Converter Clutch
Back Pressure
Valve Kit**

56947J-63K

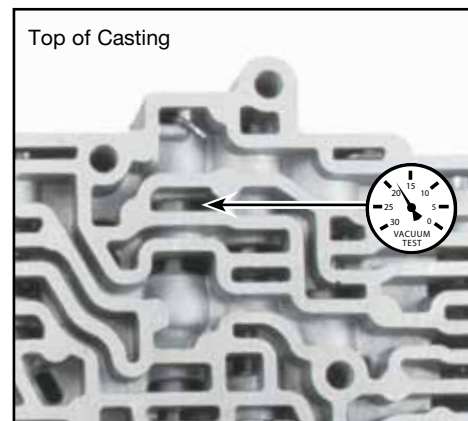
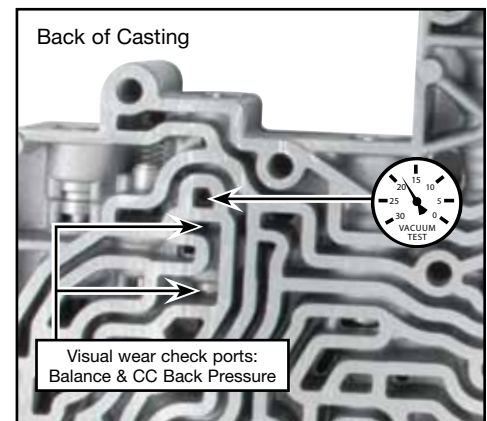
Vacuum testing shows wear or leakage.
